Inventory Number: 14-1989 Hitchcock/Davis Farm Harford County, Maryland C. Mazurek 12/28/99

### Maryland Historical Trust Maryland Inventory of Historic Properties Form

Survey No. HA-1989

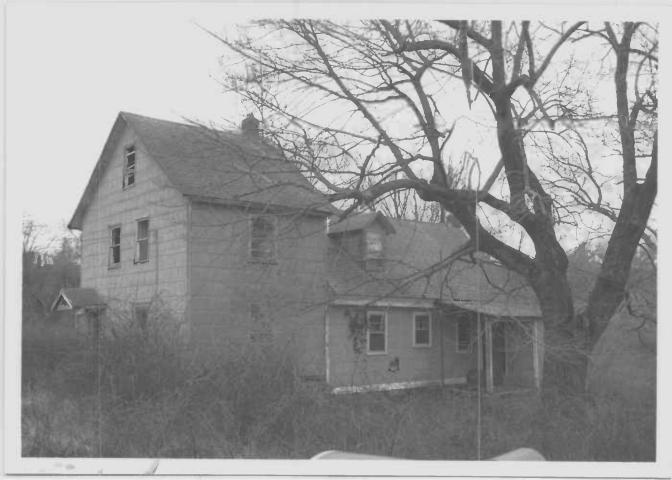
1052

DEPT. OF NATURAL RESOURCES FARMHOUSE, N.E. I LEVATIONS

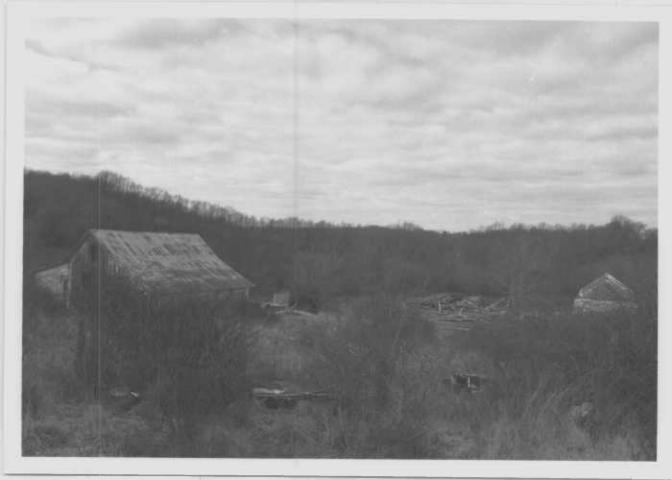
DEPT, OF NATURAL RESOURCES VIEW OF BARAS; FACING NORTH 2 0 = 2
